Log of Horizon

Buoy Laying Intermediate Site
Project MOHOLE Experimental Drilling
Feb. 18, 1961

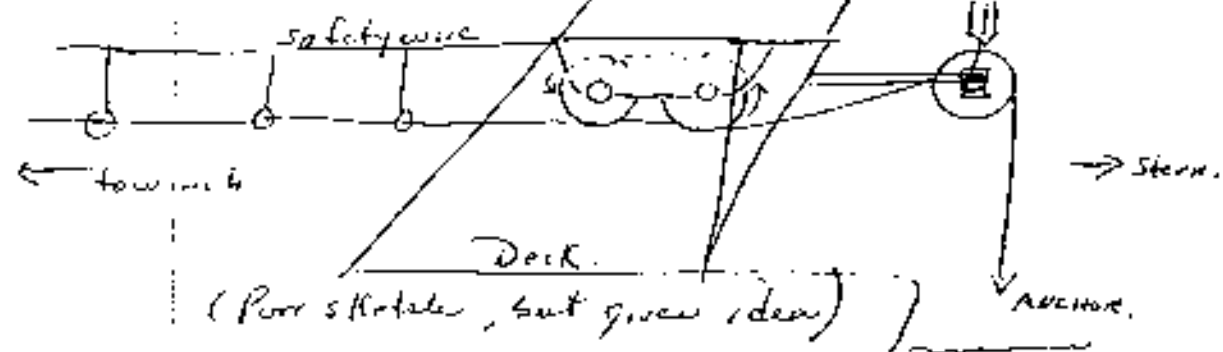
Continued splicing wire and installed the air brake accumulator at the A frame

Had to reinforce A frame to accept load without excessive vibration - it also seemed wise to install a ring safety wire (See sketch above)

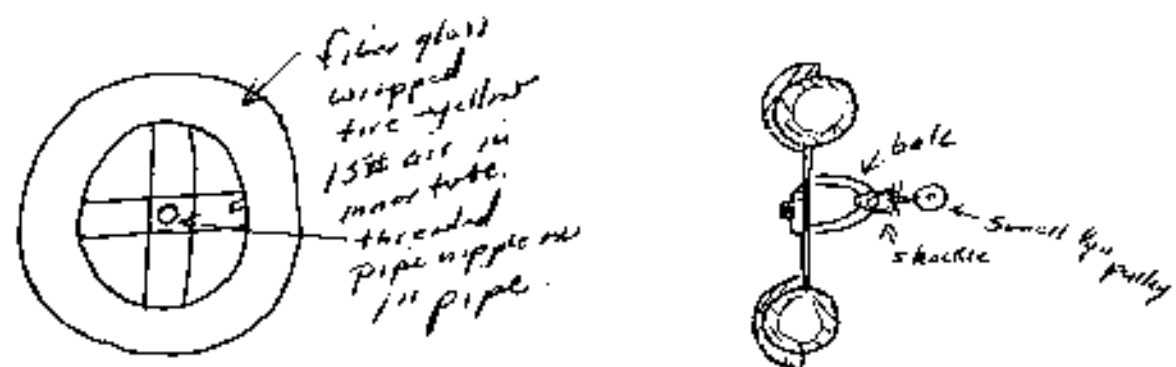
1330: Second buoy in station and settled out to be 1350 ft from 1st buoy. Launched skiff and proceeded to make final surface connections on the surface buoys and to install mounts and lights. Using Sweet surface float - 3 ft in diameter because the two buoys are to be some way with no radar mounts.

Pulled slack out of wire until boat almost directly over buoy and secured 27 lb lead sash weight to end of wire using shackles, thimble and 2 nice presses (only necessary). Left 25 ft of overlap on pulley. See over.

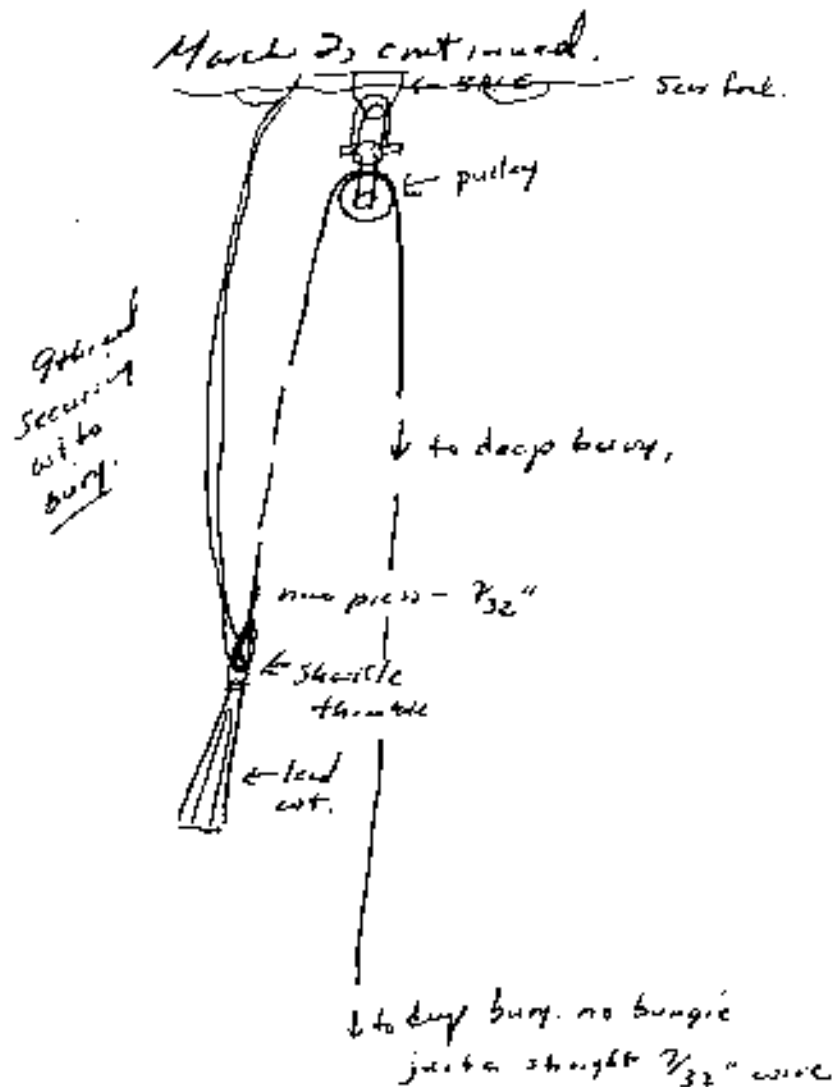
The masts were 1" Aluminum pipe, threaded to the 1" pipe nipple. A battery box was brazed to the Aluminum mast about 1' (ft) from the bottom. A red flag and small transitional white light fixed to the top.

1630 hours One mast broken off of 2nd buoy. Discovered it broke at thread because only welding on 2 threads. Lunched 5 ft and proceeded to repair mast and check both buoy connections, all but 15 ft of wire was pulled up so wt only 15 ft below buoy. All connections seem OK. It is very calm and so clear that buoys can be seen from the surface (the mast westerly but anyway).
