Log of Horizon

Buoy Laying Intermediate Site
Project MOHOLE Experimental Drilling
Feb. 18, 1961

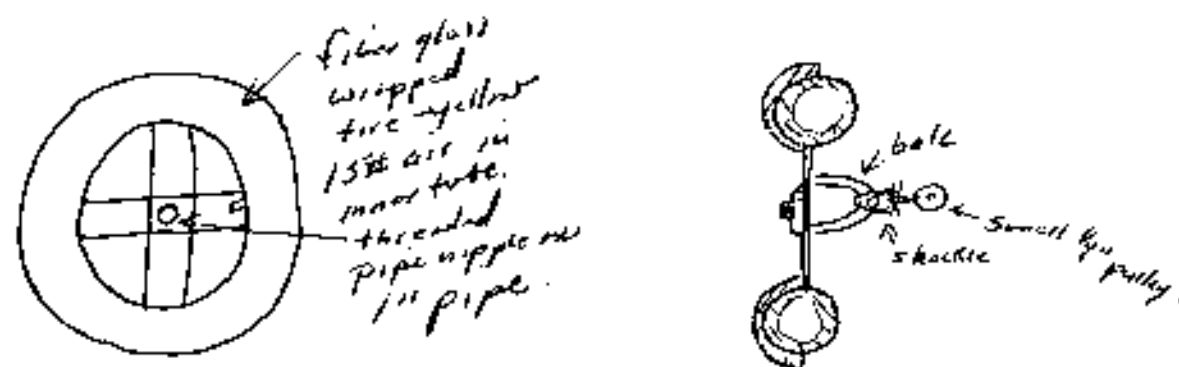
1330: Second buoy in station and settled out to be 1350 ft from 1st buoy. Launched skiff and proceeded to make final surface connections on the surface buoys and to install mounts and lights. Using Sweet surface float - 3 ft in diameter because the two buoys are to be some way with no radar mounts.
