Log of Horizon

Buoy Laying Intermediate Site
Project MOHOLE Experimental Drilling
Feb. 18, 1961

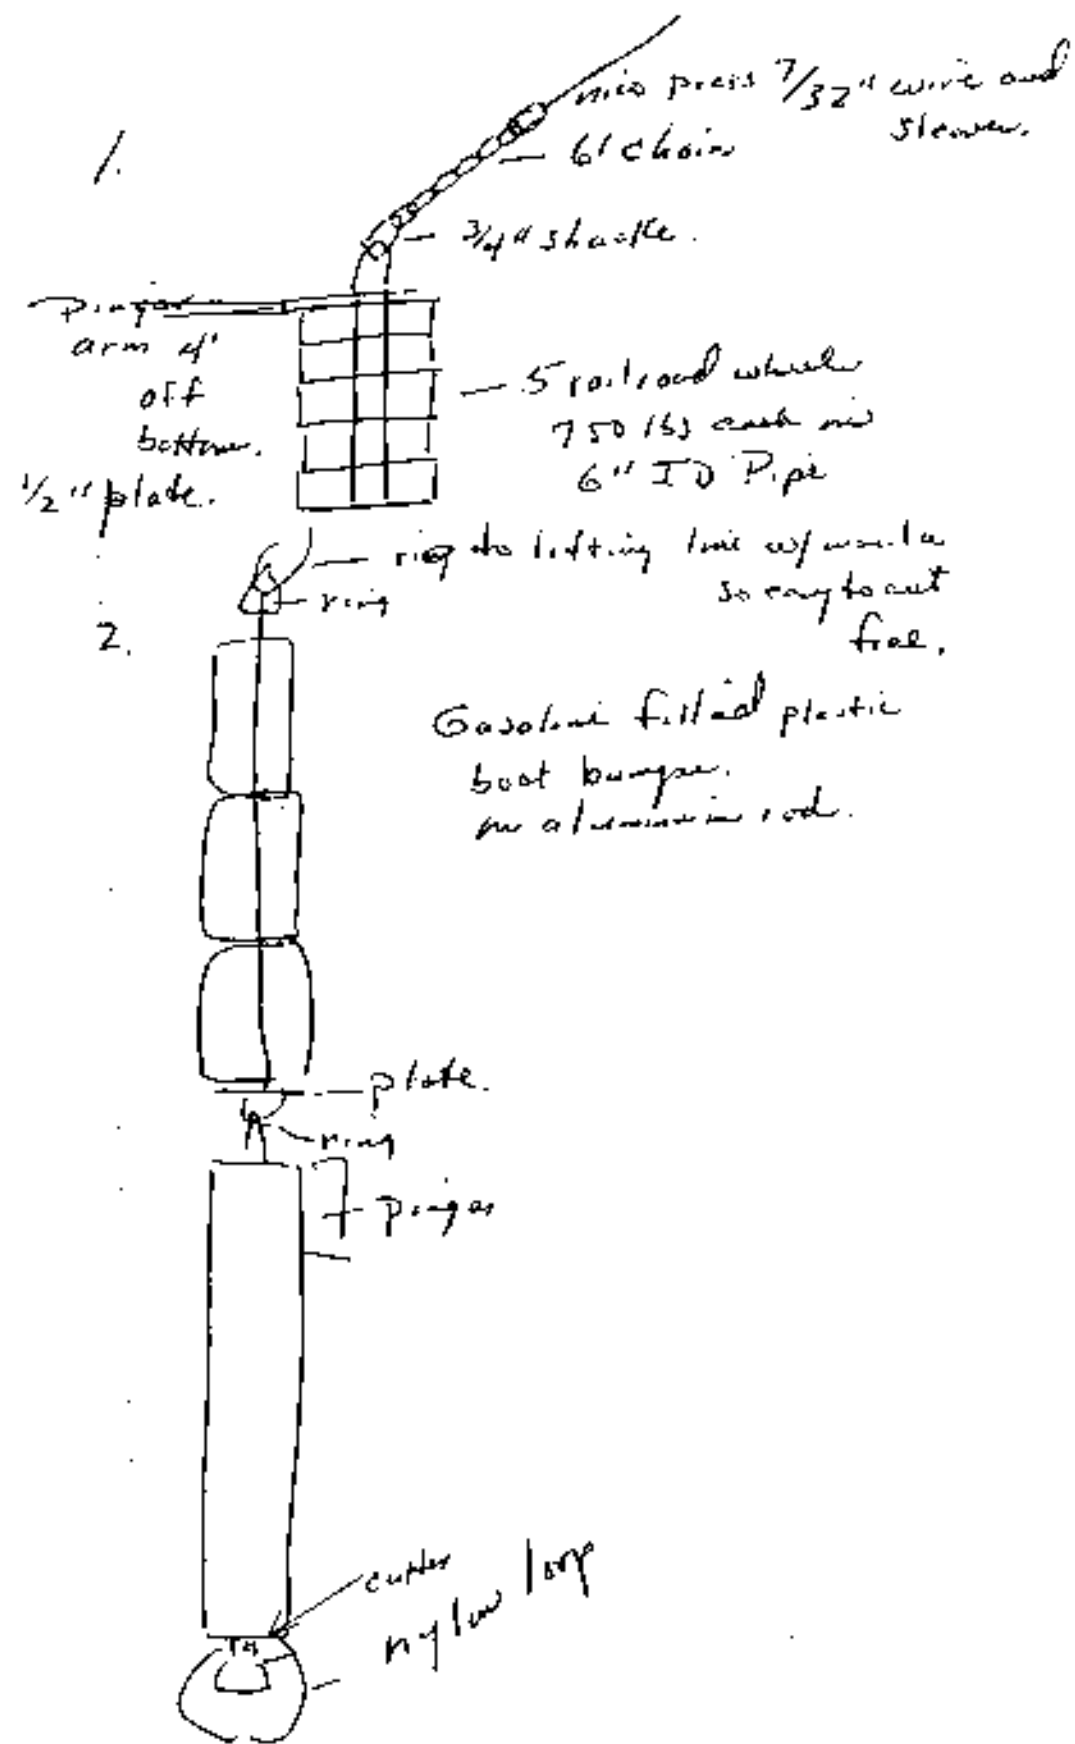
Commenced making connections - Experienced
 difficulty with pinger floats filled with
 gasoline. Buoy transponder w/ quitoline

Attachment assembled. Lower shear floats with
 25# wt. - floated OK.

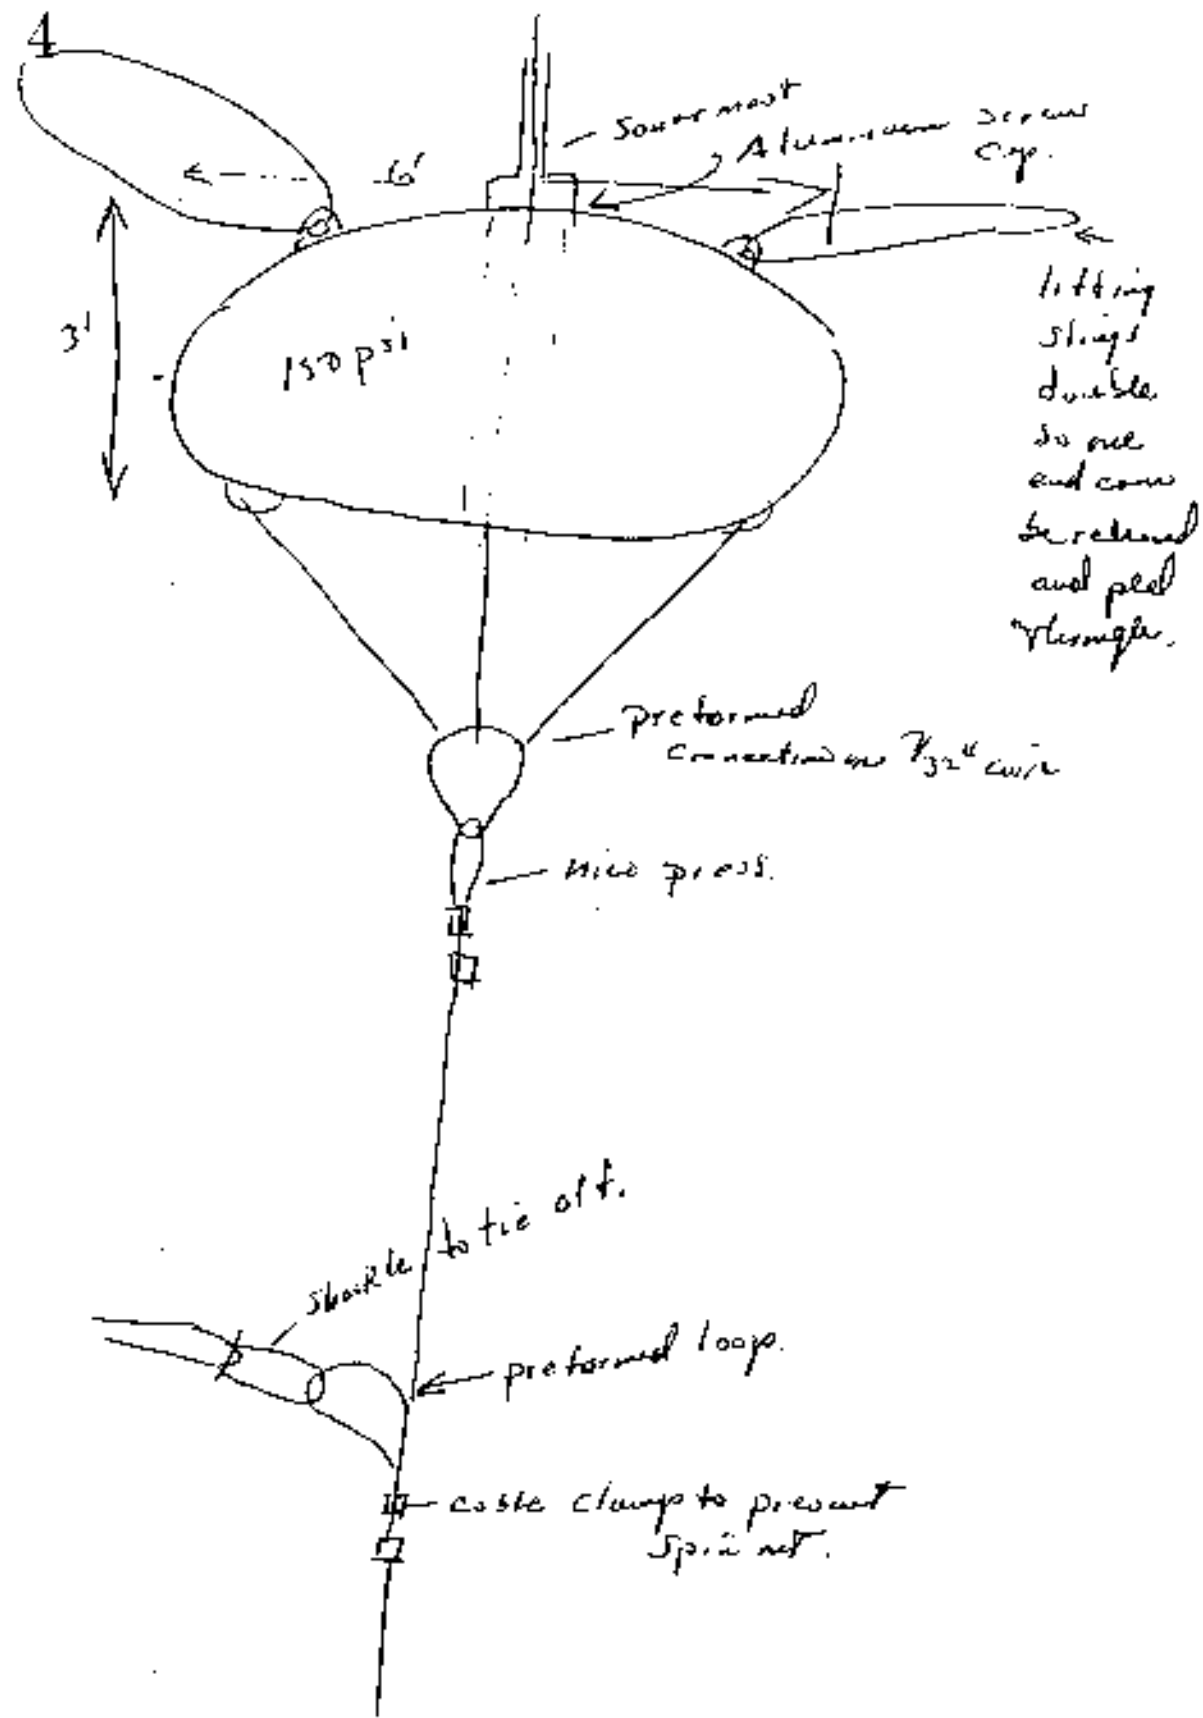
Pulled back and started slacks in bitter end
 of 7/32" and secured to lower ring with
 nice press sleeve - only one really taking
 load - slack between them.
 Lifted out away tie off,
 lower buoy on cargo winch - ~~7/32" fast load~~
 but not all load on topping winch and
 there is a slight drop of buoy on cargo 3/16"
 get line held. Snubbing buoy using two
 Manila frapping lines on A frame legs -
 buoy does not sway much in 2' to 3' swell.

1635 Start to lower buoy - Anchor ports of
 nice press fitting on lower ring. Almost
 immediately pull back buoy and secure -
 through for day. Must always secure buoys
 at all times - it rolled earlier - almost crushed down.

1. Cargo line block to be improved.
2. Manila lifting block for pringer lifting.
3. Tie off snub - wire parts became
 no ~~strong~~ - never put load on braided wire
 with no ~~stems~~ thimble.
4. Boat bumper gasoline buoy leak.
5. Pringer guillotine hole ragged and
 probably cut by line. Nylon shows empty.
6. Many hand tools missing - must be
 purchased.
7. Meter read out upside down.
8. Need work boat stand up by north
 side.
